RICS  
**Building Survey**

Property address

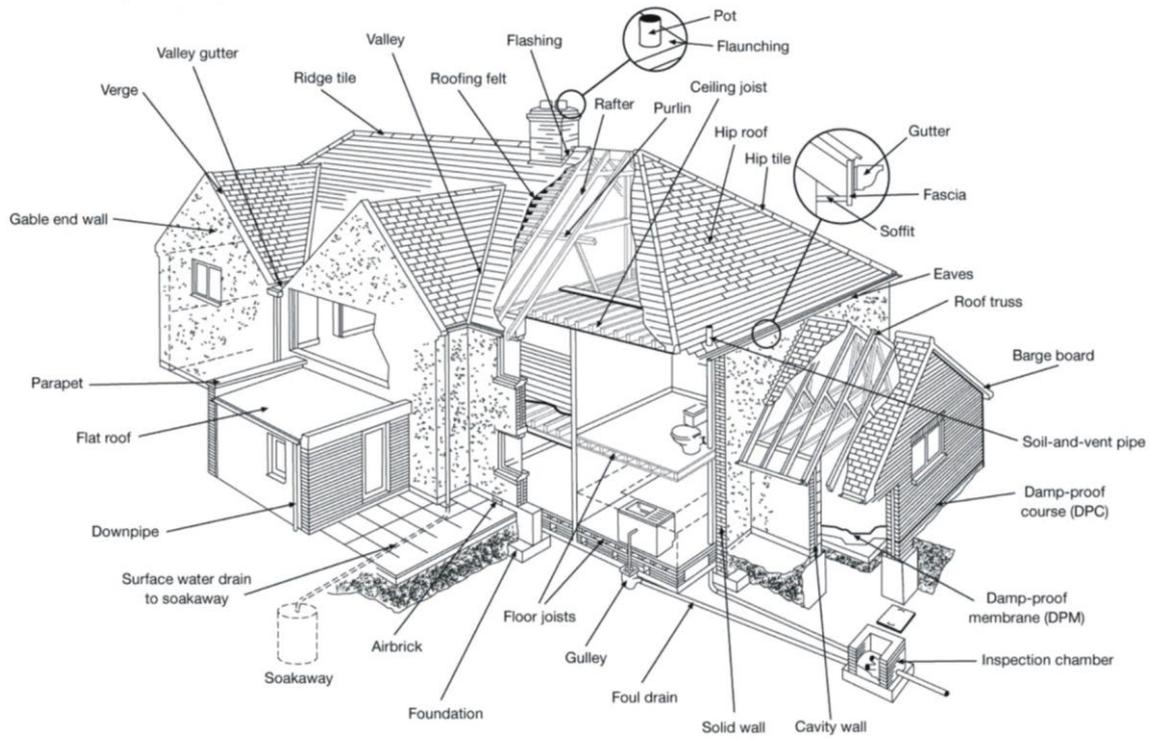
This diagram illustrates where you may find some of the building elements referred to in the report.
